Manhole Inspection Summary

Manhole # S53G__005MH

Insp Date: **4/15/08 9:27 AM**

Location Address: **3311 E pratt st**

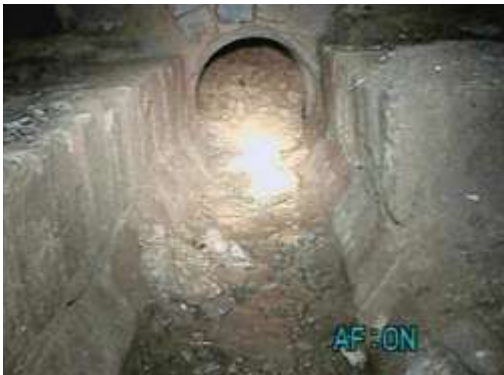
Defect 3

Condition: ☐ Sound ☐ Cracked ☐ Root Intrusion ☐ Deteriorated ☐ Leaks ☒ **Debris**

channel cond debris

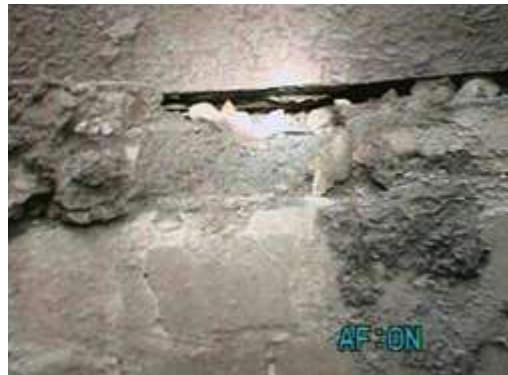
Defect 2

Condition: ☐ Sound ☐ Cracked ☐ Root Intrusion ☒ **Loose Brick** ☒ **Deteriorated**

loose brick in corbel

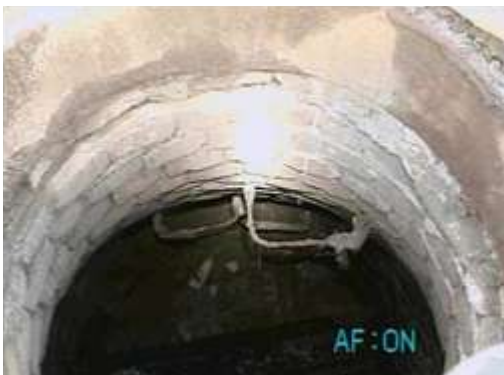
Defect 1

Count: **3** Missing: **0** ☒ **Corroded**

corroded stairs

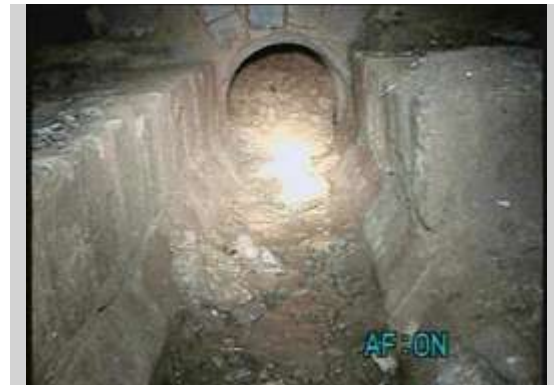
Drop In @ 6 O'Clock

Drop: **Outside Direct**
Angled: Reading: **0.00** (ft.)
Inv Depth: **7.80** (ft.)
Drop Condition: **Clogged**
